Diagnosis of abnormal temperature rise observed on a 275 kv oil-filled cable surface: a case study

Diagnosis of Abnormal Temperature Rise Observed on a 275 kV Oil-filled Cable Surface – A Case Study

ABSTRACT

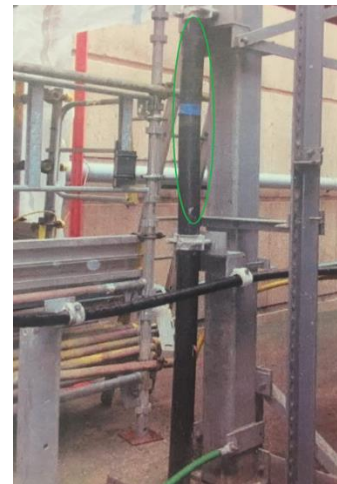
As shown in Figure 3, the Blue phase is apparently bent between two cleats which are used to fix the cable. In Nov. 2017, an inspection via infrared thermal images of the three phase cable, at 6 °C ambient temperature, revealed a local cable surface temperature rise of 5.2 °C above other phases around the bent area of Blue phase (in Figure 4). In details, the temperature of Blue phase was 17 °C which was 11 °C rise above the ambient temperature, while the temperature of the other phases were 11.8 °C which were 5.8 °C higher than the ambient temperature.

Figure 3. 275kV OF cable (Blue Phase) – the area marked in the green ellipse was observed to have a 5.2°C temperature rise.

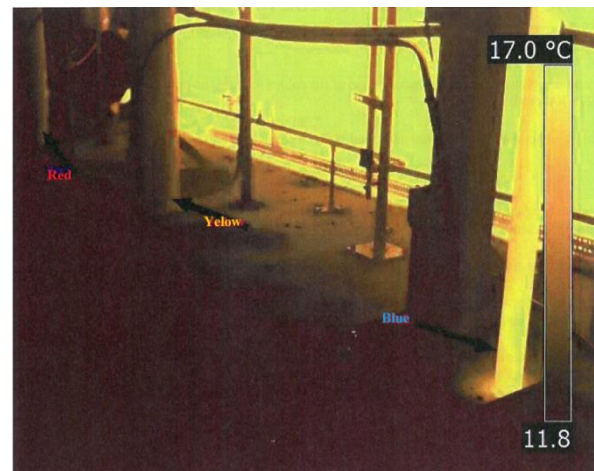
Figure 4. Infrared thermal image of the Blue Phase.

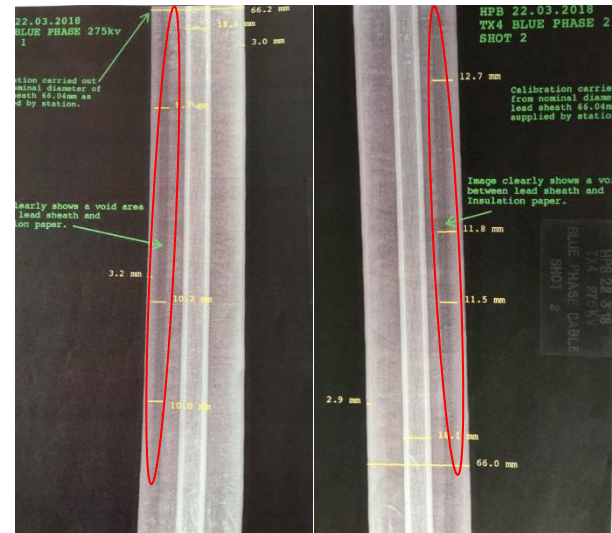
An X-ray technique was used to help researchers confirm the proposed fault diagnoses. The X-ray images were taken from both front and back side of the Blue Phase, as shown in Figure 12a and Figure 12b, respectively. Cable

construction is clearly displayed in the two X-ray images. Slight distortion of the cable can be demonstrated from inconsistent outer diameters of lead sheath, which are 66.2 and 66.0 mm respectively, and various thickness of the lead sheath which are 2.9, 3.2 and 3.0 mm respectively. The red ellipses in Figure 12a and Figure 12b show the oil region between the cable insulation and lead sheath, this has different widths at various positions.

(a) Front images (b) Rear images
– the red ellipse shows the area of oil leakage

Figure 12. X-ray images of Blue Phase cable acquired on March 22nd 2018.

The images show that the thickness of the lead sheath varies, i.e. 3.2, 3.0 and 2.9 mm. The diameter of the conductor is shown to be 18.1 mm and the outer diameter of the lead sheath is shown to vary between 66.2 and 66.0 mm. The X-ray images also indicate a narrow region between cable insulation and lead sheath filled with oil. The lengths of the void at various positions in Figure 12a are measured as 9.7, 10.0 and 10.2 mm and in Figure 12b as 12.7, 11.8 and 11.5 mm. As shown in Figure 12c, an oil filled region between the cable insulation and lead sheath, approximately one meter in length, may have been responsible for the abnormal temperature rise. As shown in Figure 13, channels formed due to distortion and deformation allow the higher
